Well head
not sealed
CANTEX

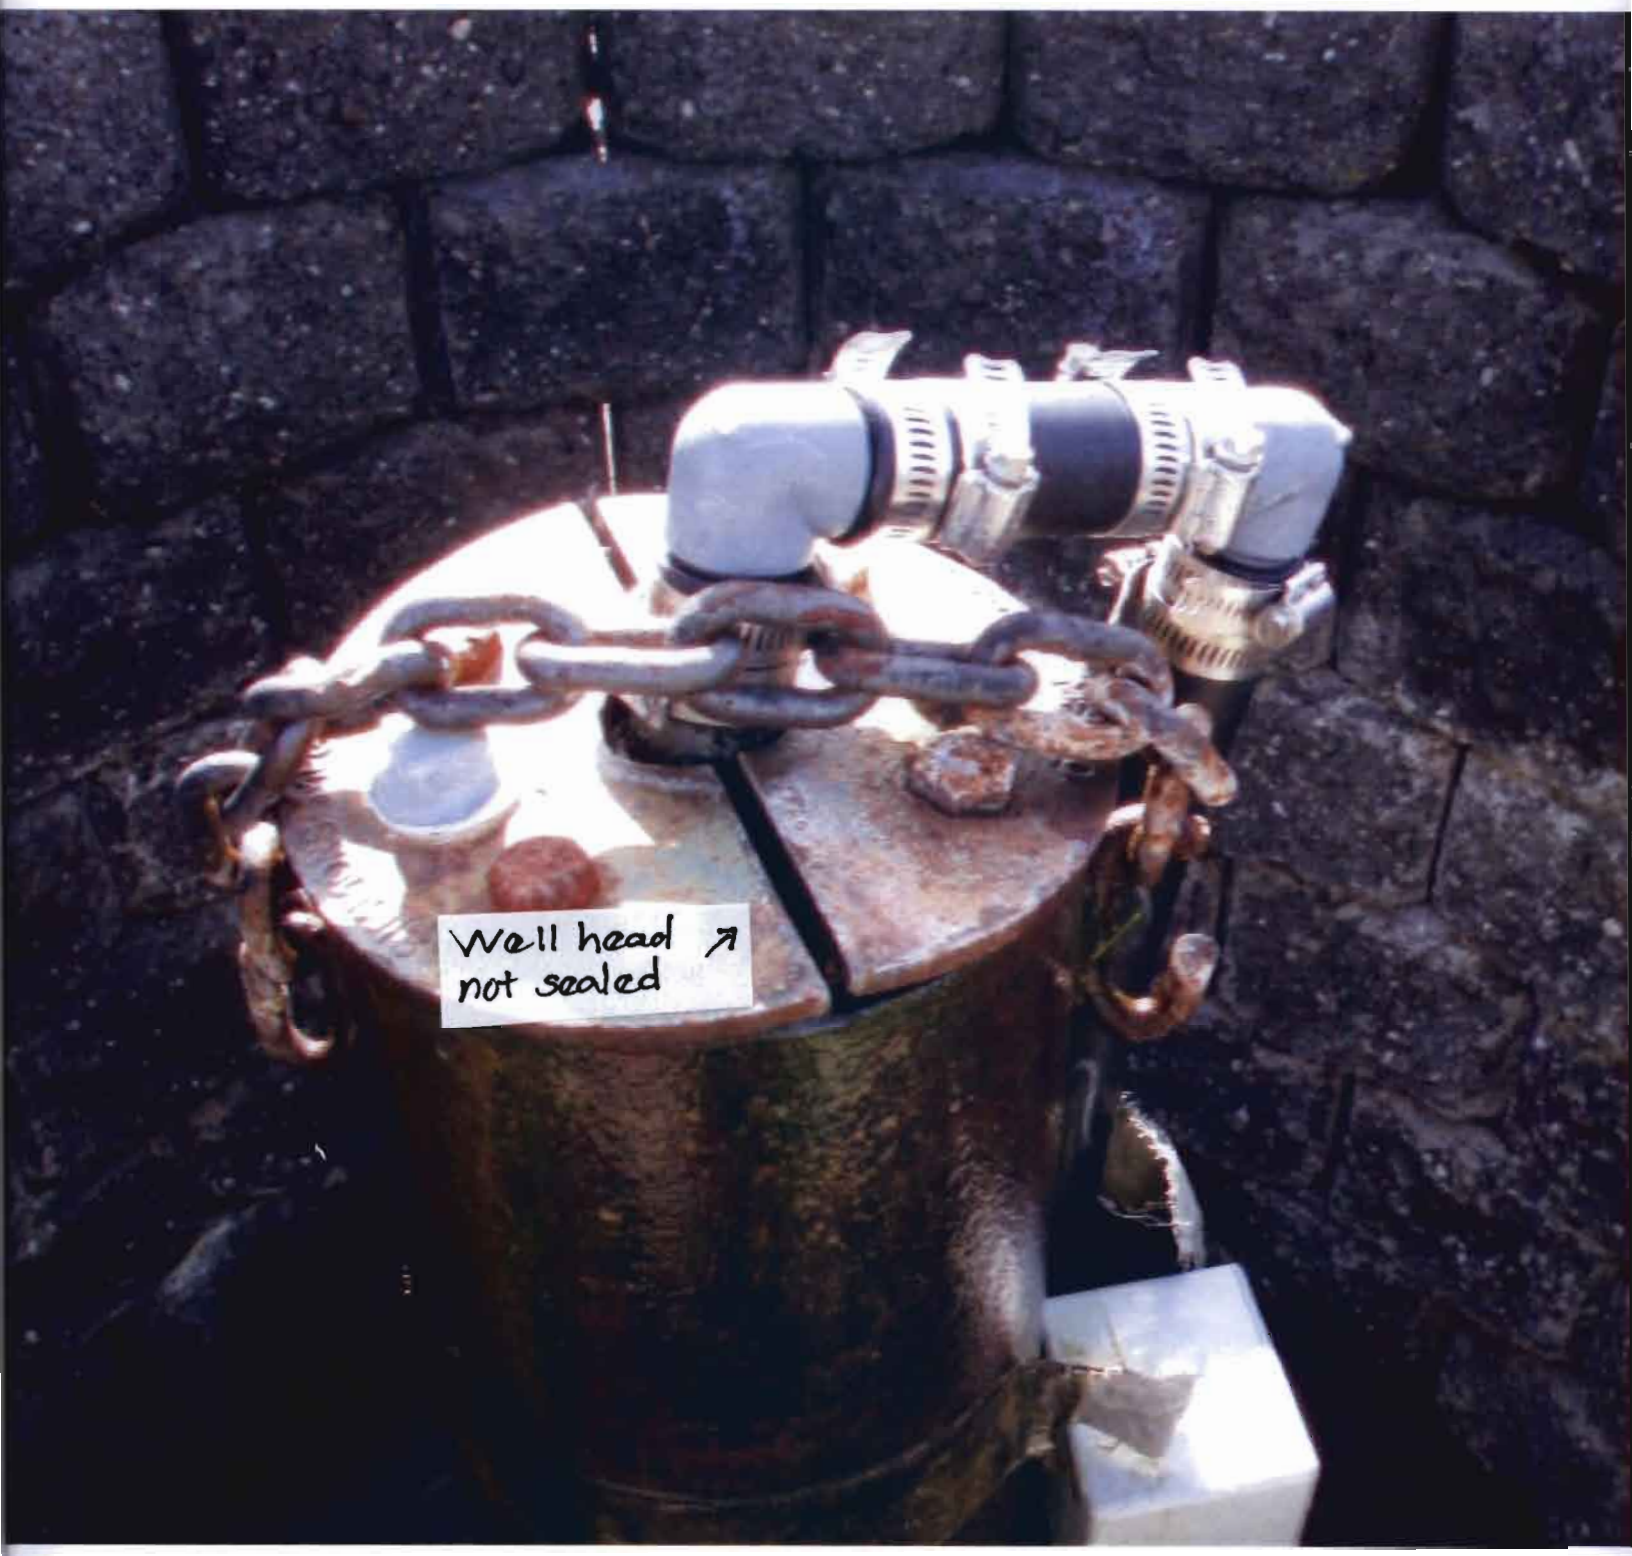
Well head ↗
not sealed

vent
All openings are sealed
sealed conduit box

Vent
vent screened underneath
casing and conduit are sealed
07 14 2017

electrical conduit
vent - must have screen
